Asbestos/Hazardous Materials Survey

Asbestos Abatement Associates was retained by Cindy Carlson of the City of St. Paul to conduct an Asbestos/Hazardous Materials Survey for a residential home located at 1554 Minnehaha Ave. E., St., St. Paul, MN. We were asked to prepare this report (the Survey) and report the findings of the Survey.

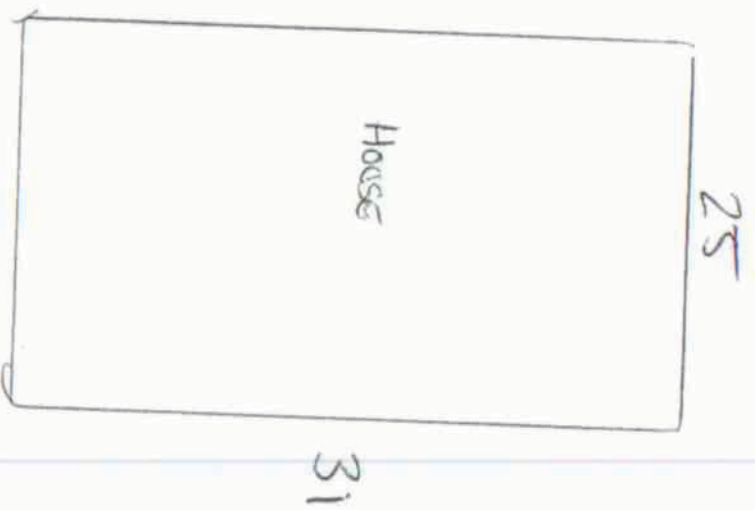
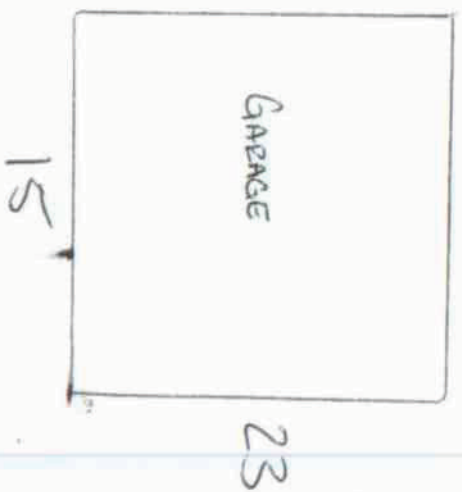
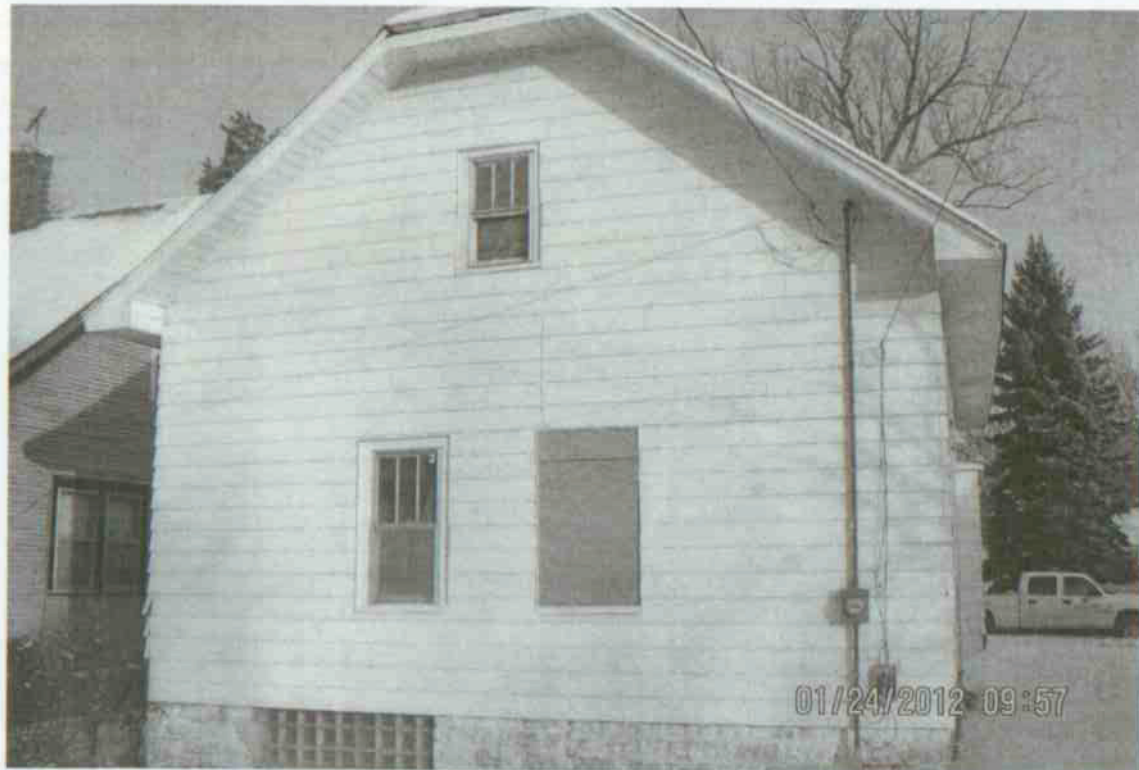
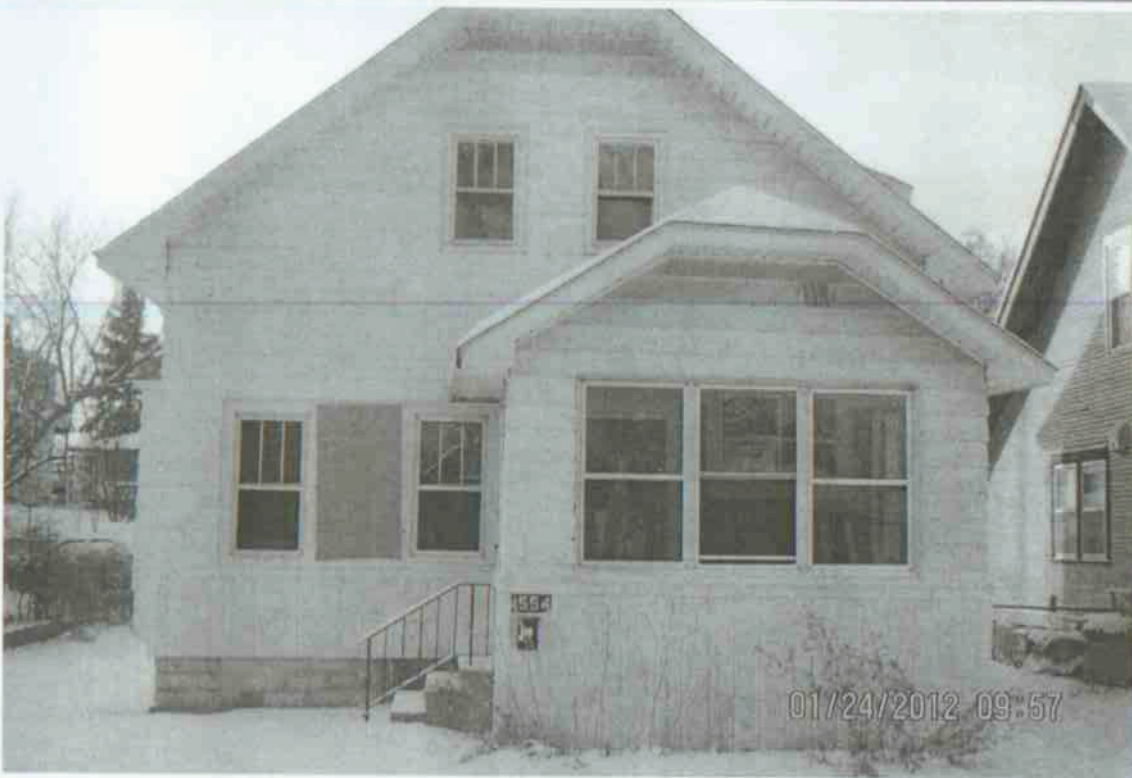
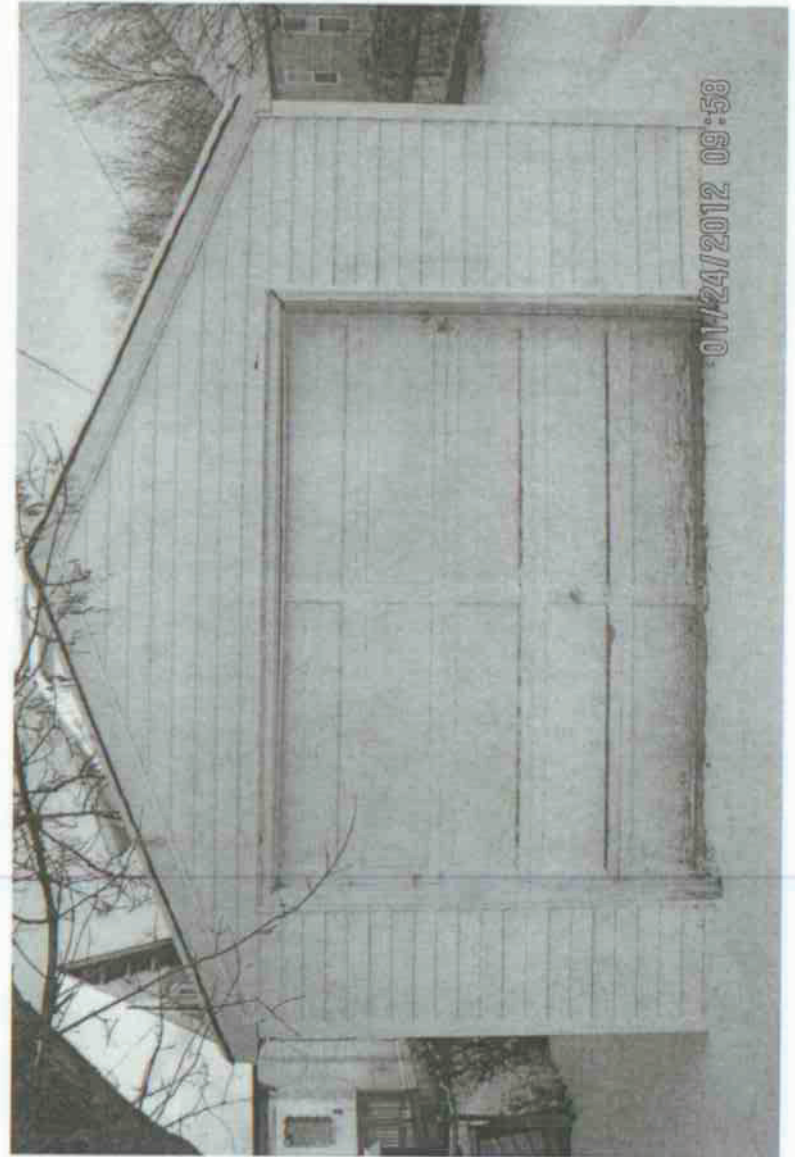
Sampling Area Measurements for Abatement 1554 Minnehaha Ave. E., St. Paul, MN

Sample #4 grey basement joists	15 linear ft.
Sample #5 grey paper heat vents kitchen 1 st floor	50 sq. ft.
Samples #6 grey paper heat vents bedroom #2 2 nd floor	40 sq. ft.
Sample #18 brown caulking electrical inlet	1 sq. ft.

Sample #4 is the grey paper on basement joists and was found to contain 65% Chrysotile Asbestos containing material and must be removed by a State Licensed Asbestos Contractor with the estimated cost for removal \$1,050.00.

Sample #5 is grey paper on heat vents kitchen 1st floor and was found to contain 65% Chrysotile Asbestos containing material and must be removed by a State Licensed Asbestos Contractor with the estimated cost for removal \$1,250.00.

Sample #6 is grey paper on heat vents bedroom #2 on 2nd floor and were found to contain 65% Chrysotile Asbestos containing material and must be removed by a State Licensed Asbestos Contractor with the estimated cost for removal \$1,050.00.
